An Asbestos Refurbishment/Demolition Survey (MA only) to the all accessible areas of rooms 138, 237 & 332 to facilitate installation of new stairwell areas of  
**LSHTM TP1 & TP2 Project**  
**15-17 Tavistock Place**  
**London**  
**WC1H 9SH**

<b>Survey Carried Out On:</b>	29 January 2019	 
<b>Commissioned By:</b>	Bhavna Khetani Kier Construction (London) 2 Langston Road Loughton Essex IG10 3SD	
<b>Date:</b>	11 March 2019	
<b>Our Reference:</b>	J138677	
<b>Surveyed By:</b>	Danny Gurnham

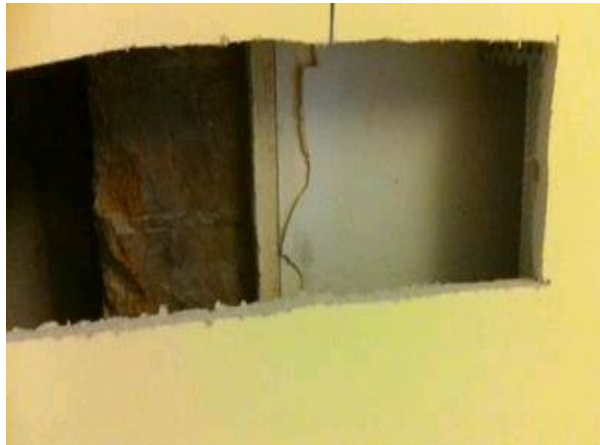
<b>Building:</b> Building 1	<b>Floor Level:</b> Third	<b>Room Name:</b> (001) Office
<b>Component:</b> Textured finish to original brickwork behind plasterboard stud walls

Sample Reference	Asbestos Type	Material	Surface Treatment Score	
DG000699 (Sample 1)	No Asbestos Detected			
Extent of damage	Material Assessment*	Accessibility	Extent/amount	Location
Recommendations				
Who	What	When		
-	No further action required	-		
<b>Further Recommendations:</b> None				
<b>General Notes:</b> Concrete ceiling above modern suspended plasterboard ceiling Textured finish to original brick walls behind plasterboard stud walls Thick screed beneath carpet tiles Metal framed windows - wooden sills Wooden access door - glass infill

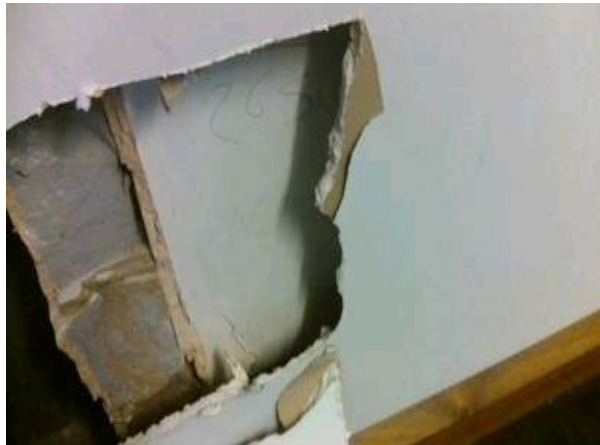
<b>Building:</b> Building 1	<b>Floor Level:</b> Second	<b>Room Name:</b> (002) Office
<b>Component:</b> Textured finish to original brickwork behind plasterboard stud walls

Sample Reference	Asbestos Type	Material	Surface Treatment Score	
DG000700 (Sample 2)	No Asbestos Detected			
Extent of damage	Material Assessment*	Accessibility	Extent/amount	Location

**General Notes:**  
 Sectional concrete ceiling above modern suspended plasterboard ceiling  
 Textured finish to original brick walls behind plasterboard stud walls  
 Thick screed beneath carpet tiles  
 Metal framed windows - wooden sills  
 Wooden access door - glass infill

Recommendations		
Who	What	When
-	No further action required	-

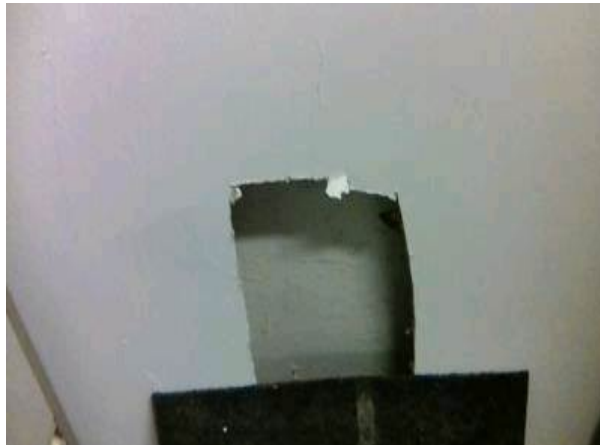
<b>Building:</b> Building 1	<b>Floor Level:</b> First	<b>Room Name:</b> (003) Office
<b>Component:</b> Textured finish to original brickwork behind plasterboard stud walls

Sample Reference	Asbestos Type	Material	Surface Treatment Score	
As DG000700 (Ref Sample 2)	No asbestos detected in visually consistent material			
Extent of damage	Material Assessment*	Accessibility	Extent/amount	Location
Recommendations				
Who	What	When		
-	No further action required	-		
<b>Further Recommendations:</b> None				
<b>General Notes:</b> Sectional concrete ceiling above modern suspended plasterboard ceiling Textured finish to original brick walls behind plasterboard stud walls Thick screed beneath carpet tiles Metal framed windows - wooden sills Wooden access door - glass infill
